Extended abstract No. 269

DESIGN OF WETLANDS REHABILITATION INTERVENTIONS IN ALPINE WETLANDS OF LESOTHO

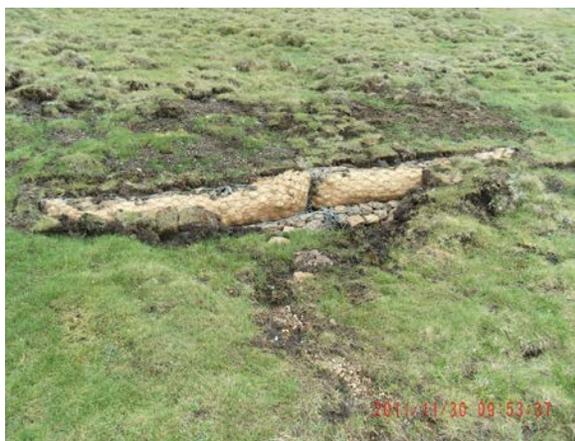
Ecologs

The following interventions are being used in the on-going Wetlands Rehabilitation and Conservation Project in the alpine Wetlands of Lesotho and their success are being closely monitored. The interventions include: Concrete Structure, Gabion Structure, Sack Gabion and Rock Packs, Ecologs, Bio-Jute, Road Cross- Drains and Revegetation.

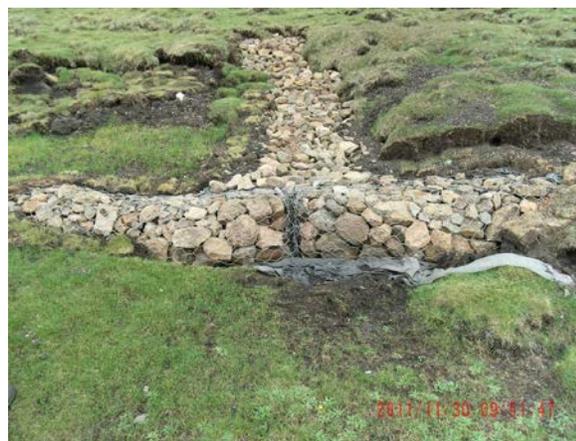
Sack Gabion and Rock Pack
