## RESTORATION OF WATER QUALITY AND BIOLOGY IN TWO REWETTED CUT-OVER PEATLANDS

### SUMMARY

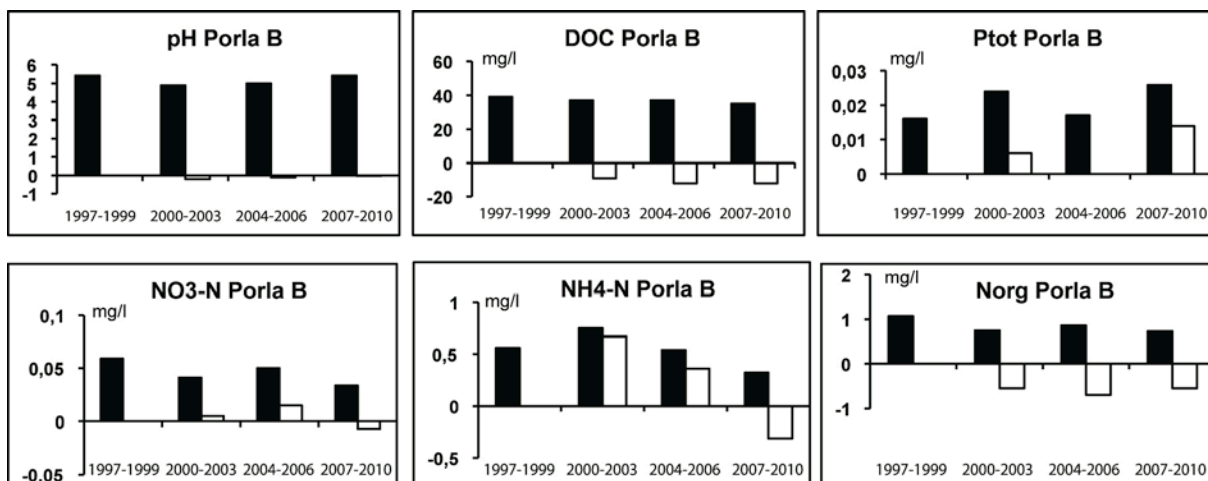
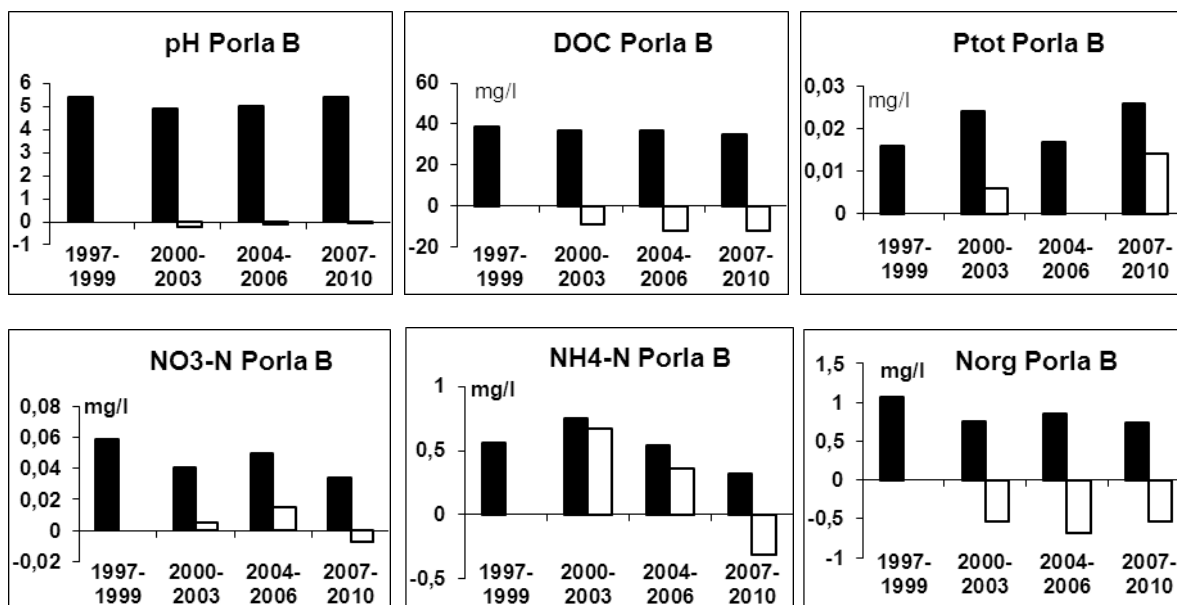
Figure 1.

Fig. 1. Water chemistry at Porla rewetting with measured values for four periods and changes after rewetting during the three later periods.

Water chemistry at the two rewetted sites show initially after rewetting a lowered pH but later increased and even reached values higher than before rewetting. Dissolved organic carbon (DOC) shows initially increased DOC at Västkärr fen after rewetting but later lower DOC concentration. This later pattern coincides with changes at Porla site where lower concentrations were experienced after rewetting (Fig. 1). Regarding phosphorus (P), there were increased contents after rewetting at both sites. However, at Västkärr fen, initially new probably reduced conditions in the bottom water released large amounts of P but after a few years, P decreased to low concentrations, probably due to planktonic and higher vegetation uptake (Fig. 2).

Base cations, especially calcium (Ca), showed lower contents after rewetting as well as total nitrogen (N) at the Porla site. Nitrate increased initially at Porla wetland but turned lower with time as was also observed at Västkärr fen. Ammonium (NH<sub>4</sub>) also increased short after rewetting at Porla wetland but mainly decreased at Västkärr fen. After ten years, NH<sub>4</sub> turned lower also at site Porla. In Västkärr fen, the sub-basin VK III received leaching water from the nearby ongoing peat excavating area up to 2001 when the outlet was changed to sub-basin VK I and NH<sub>4</sub> content decreased at VK III but instead increased in VK I (Fig. 2). In conclusion, however, rewetting seems to lead to a decreased nutrient content in the wetlands.

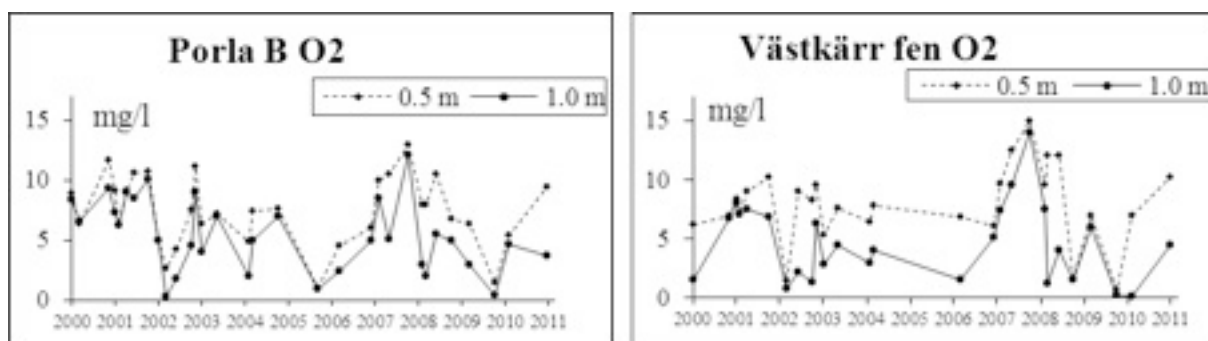
Figure 3.

Fig. 3. Oxygen content in the two rewetted sites.

Water quality was to a large extent controlled by the oxygen (O<sub>2</sub>) content and in the shallow wetland lakes, water turnover could be fast and sensitive to wind. This furnishes often fairly good conditions with existing O<sub>2</sub> content. However, in stagnation periods and especially in the deep bottom water, depletion of O<sub>2</sub> content could appear. This occurred a number of times in the two wetlands (Fig. 3).

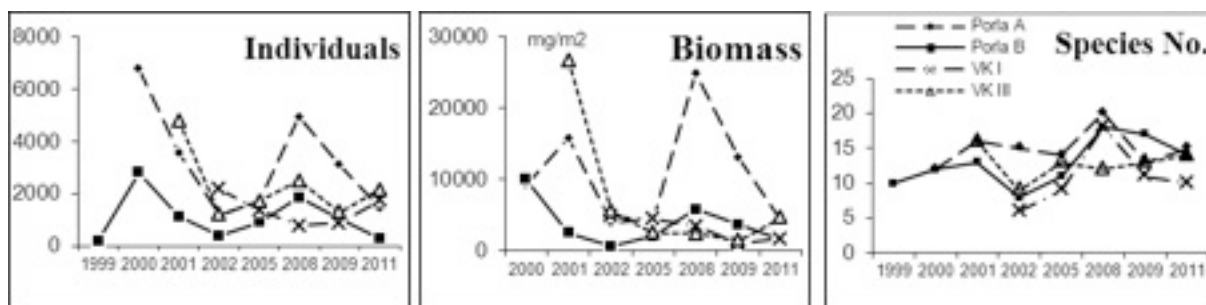
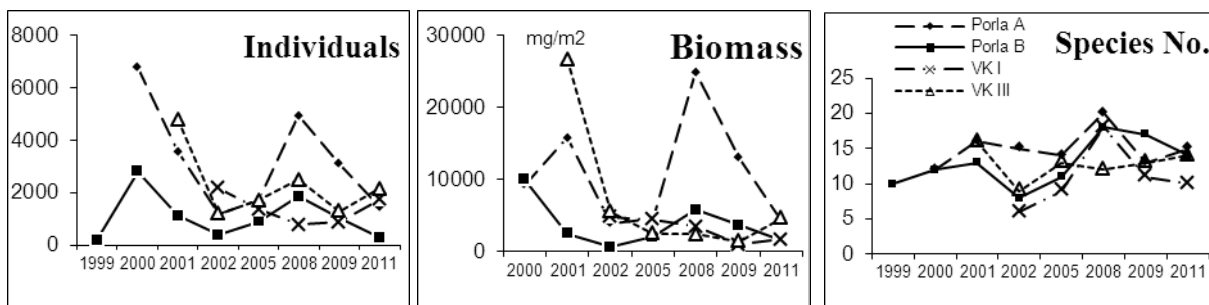
Figure 4.

Fig. 4. Number benthic fauna individuals and species and biomass content in Porla and Västkärr fen wetlands.

The benthic fauna in the Porla wetland is species poor but tolerant to acidification and the number of species has increased (Fig. 4). The groups dominating in the early wetland period were collectors, scrapers, and shredders but most of these decreased over time and after ten years predators dominate. In the bottom layers (1-2 m), the species indicate O<sub>2</sub> depletion. This was especially evident in the year 2002.

The number of the phantom midge *Chaoborus flavicans* was large and indicated high invertebrate production. In the Västkärr fen, the number of species, individuals and biomass varied considerably and 4-5 years after rewetting, there occurred deteriorated water quality conditions with low values as consequence. One of the sites (VK III) was considered rich in individuals in 2001 but this decreased. Bottom fauna conditions improved later with increased numbers and biomass but have again, in the last three years, slightly decreased (Fig. 4).

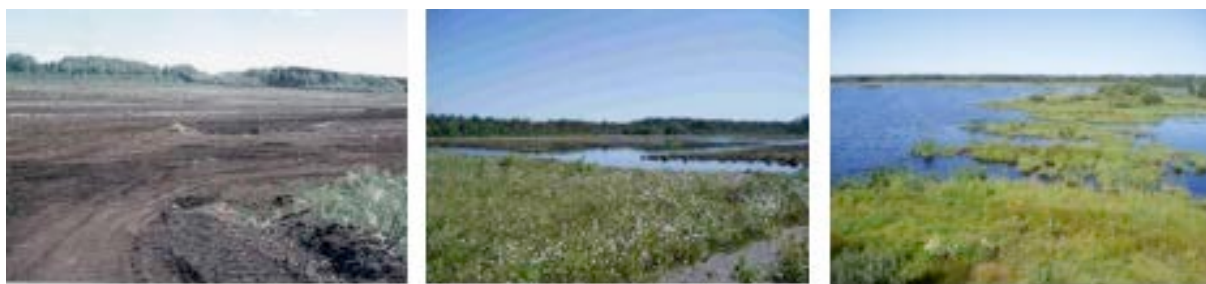
Figure 5.

Fig. 5. The peatlands before and after rewetting. The middle figure shows Porla site eight years after rewetting and the right figure Västkärr fen after the same time.

At the Porla site, maybe as a result of the fairly poor nutrient conditions, the spontaneous plant re-colonization within the first 3-5 years was dominated by *Eriophorum vaginatum* (5-40%) tussocks with a good presence of *Eriophorum angustifolium* (2-30%) at many locations (Fig. 5). Other occurring species were *Drosera rotundifolia*, *Scirpus caespitosus*, *Betula pubescens* and *Polytrichum commune*. About ten years after rewetting *Eriophorum vaginatum* still dominated with coverage of 20-90%. Also *Eriophorum angustifolium* was common with 5 to 50% and *Drosera* spp, *Betula* spp., *Utricularia minor*, *Juncus* sp. and *Rhynchospora alba* were found in many places. In a few places *Sphagnum* colonization started in 2006 and increased after that with patch sizes in 2010 ranging from 0.1 to 1 m<sup>2</sup>.

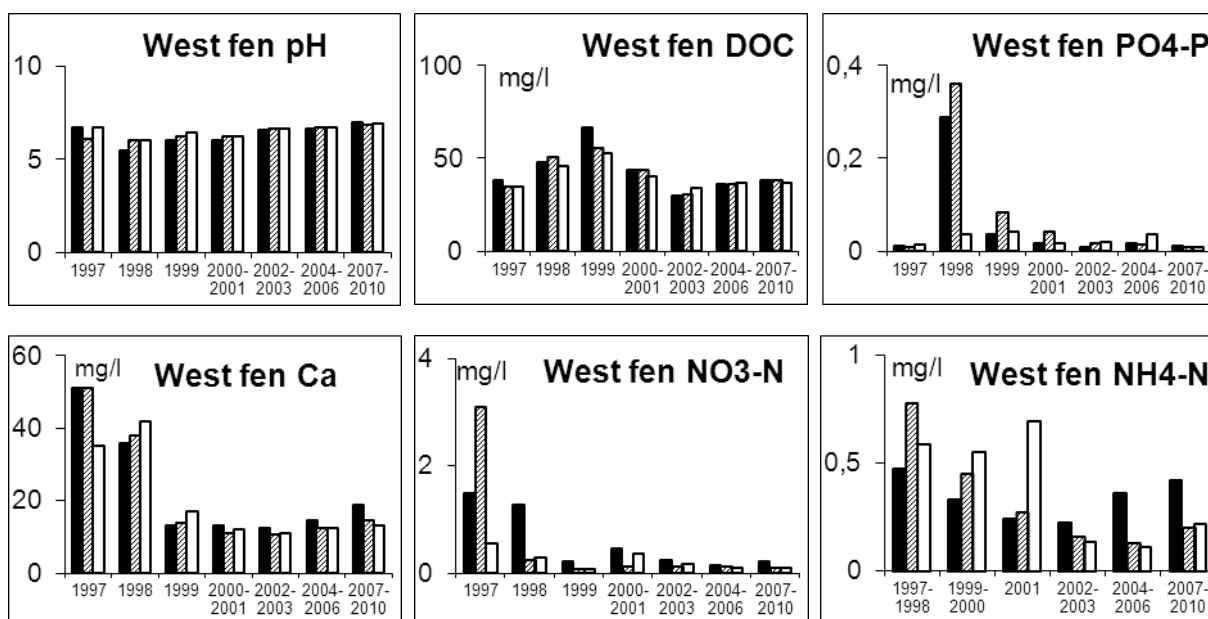
Figure 2.

Fig. 2. Water chemistry at the three basins at Västkärr fen during 1977 – 2010. VK I solid bar, VK II hatched bar and VK III open bar.
